# Glengarda Child and Family Services Reno

## Sustainable design begins with building upgrade, re-use

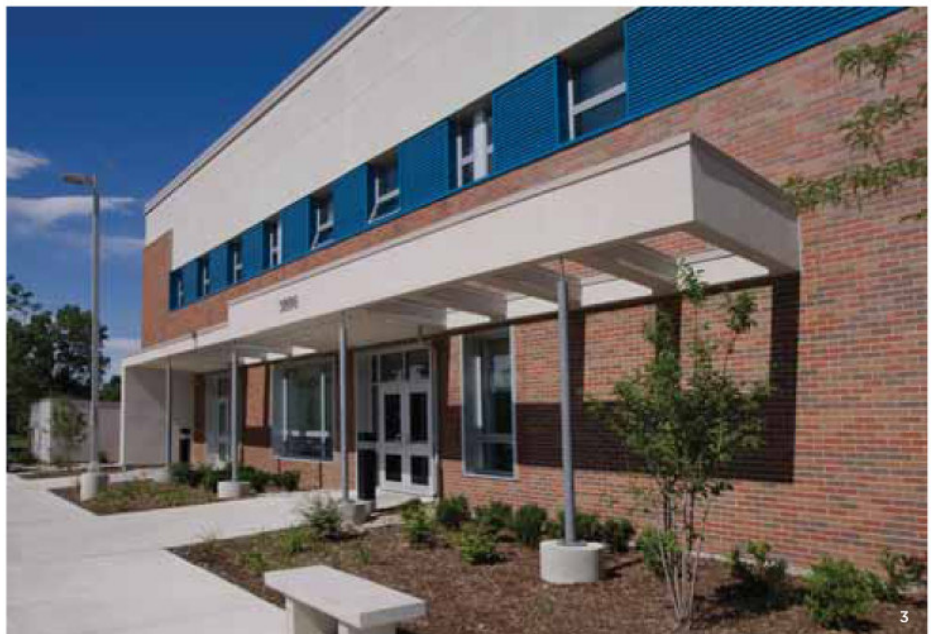
THE MAIN LOBBY/ATRIUM WITH DOORS LEADING TO THE LIBRARY AND RESOURCE ROOM. UPGRADED INSULATION, A NEW GREEN ROOF, AND ENERGY RECOVERY VENTILATORS HELPED TO MAKE THE RENOVATED BUILDING 64.4% MORE ENERGY EFFICIENT THAN A BUILDING DESIGNED TO THE MNECB [1]. THE SECOND-STORY BRICK VENEER WAS REMOVED AND REPLACED WITH AN EIFS SYSTEM TO BETTER ELIMINATE THERMAL BRIDGING AT THE ROOF LEVEL [2]. MAIN ENTRANCE. THE ORIGINAL BRICK WAS MAINTAINED ON THE FIRST FLOOR EXTERIOR, AND ALL WINDOWS WERE REPLACED WITH FIBREGLASS WINDOW FRAMES AND LOW-E, ARGON GAS-FILLED GLAZING [3].

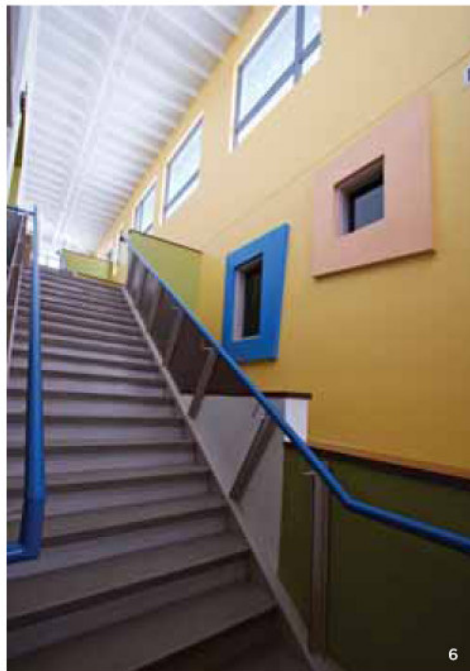
6

TYPICAL CORRIDOR SHOWING STRONG USE OF COLOUR AND PLENTY OF NATURAL LIGHT ADMITTED THROUGH CLERESTORY WINDOWS. ALL PAINT IS LOW-VOC [4,7]. MANY OF THE WINDOWS ARE OPERABLE FOR NATURAL VENTILATION SUCH AS IN THIS CLASSROOM [5]. THE STAIR TO THE GREEN ROOF VIEWING LANDING [6]. THE LIBRARY AND RESOURCE ROOM. MANY OF THE FLOOR AREAS ARE FINISHED WITH DURABLE, NATURAL, COLOURFUL LINOLEUM [8].

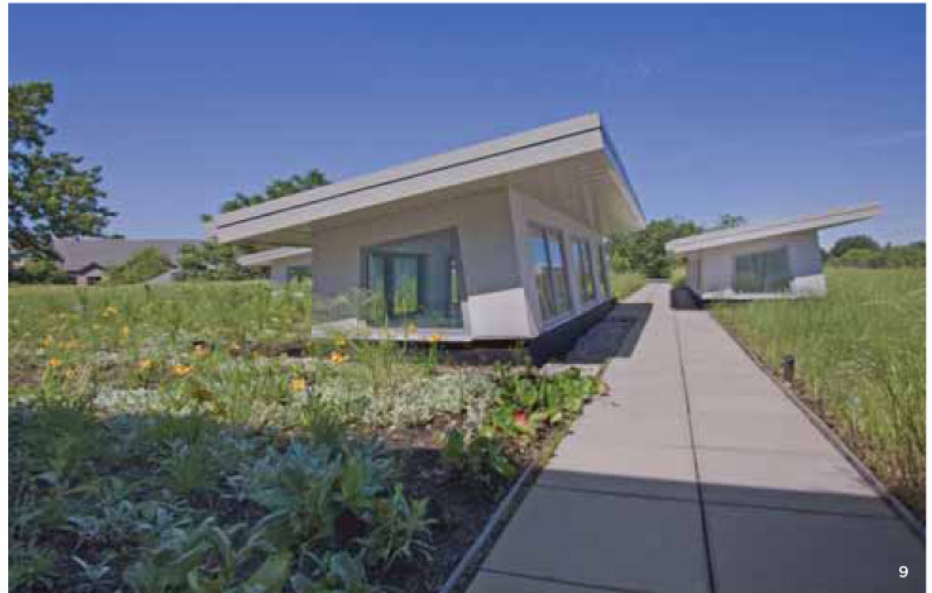
ROOF-TOP MONITORS ON THE GREEN ROOF BRING NATURAL LIGHT INTO THE CORE OF THE BUILDING [9].
